ROV Sprinkler Tank Inspection Sample Report

Reference: 123456789

Date of Inspection: 00/00/0000

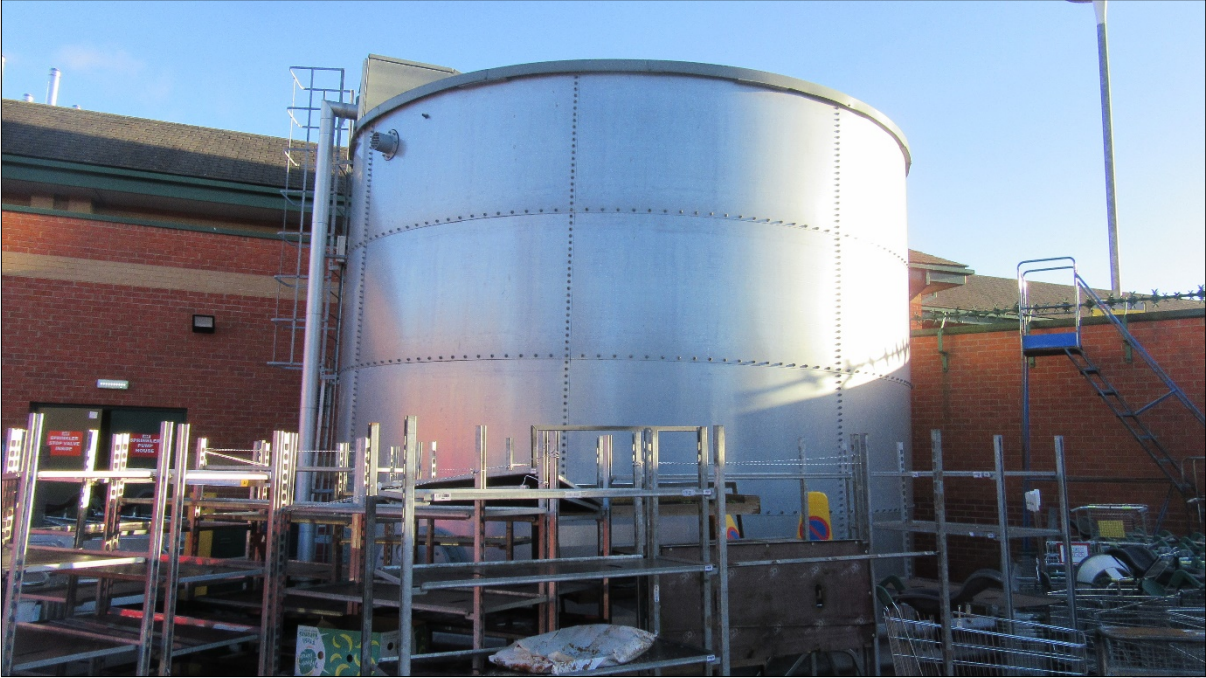
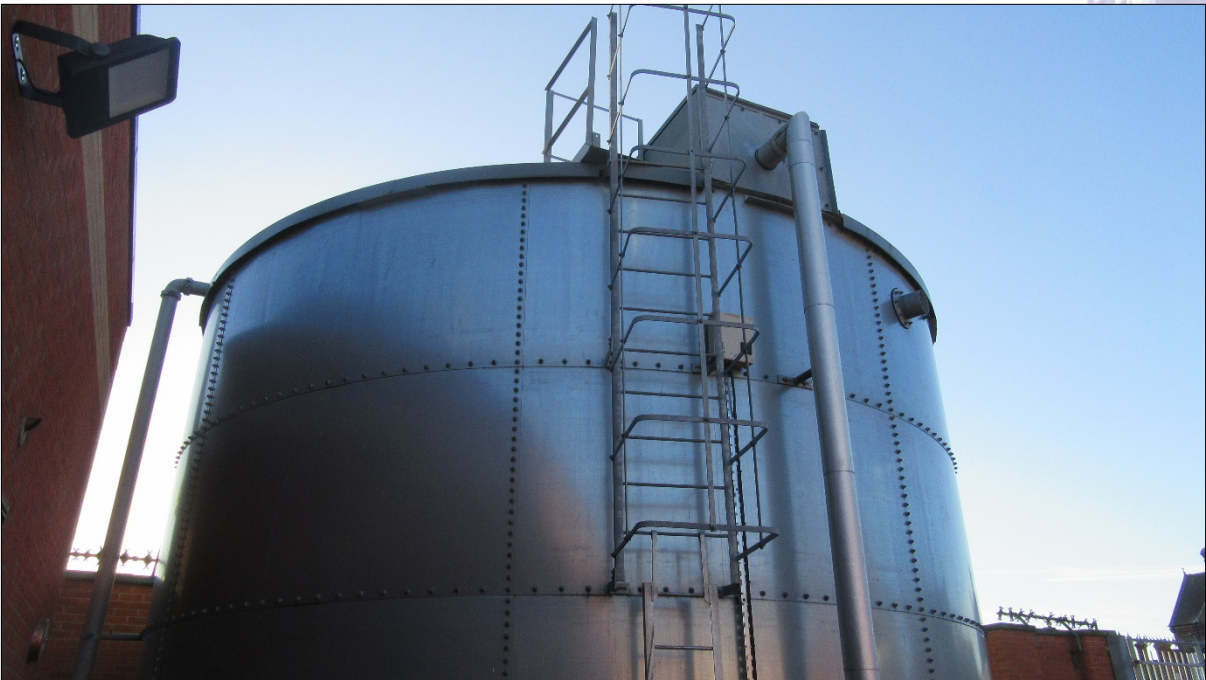
Note: The tank is in a serviceable condition.

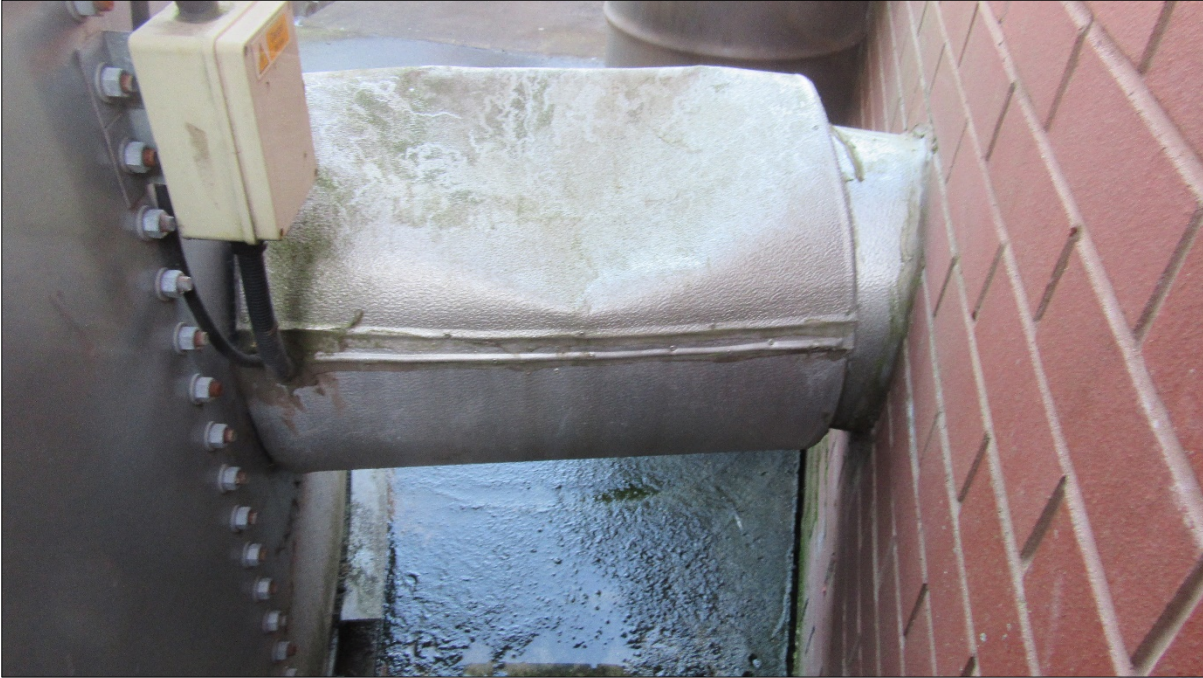
External Suction

Note: The lagging is damaged.

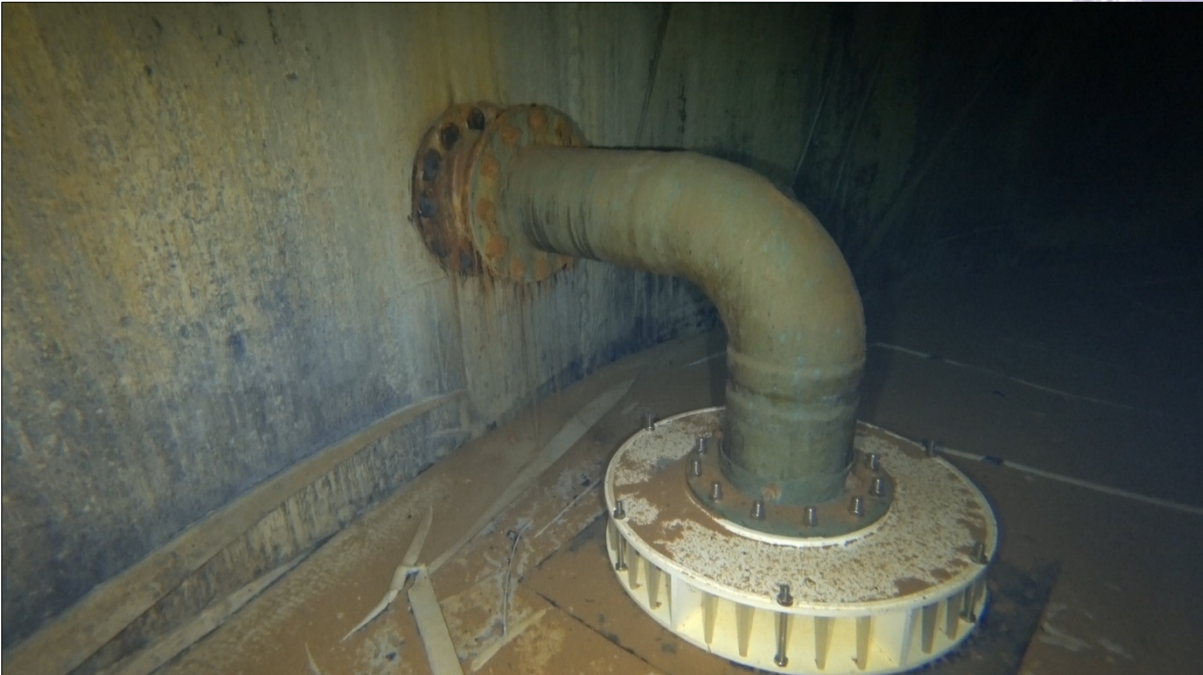
ROV Image of Suction

Note: [Corrosion](#) is present on the spool.

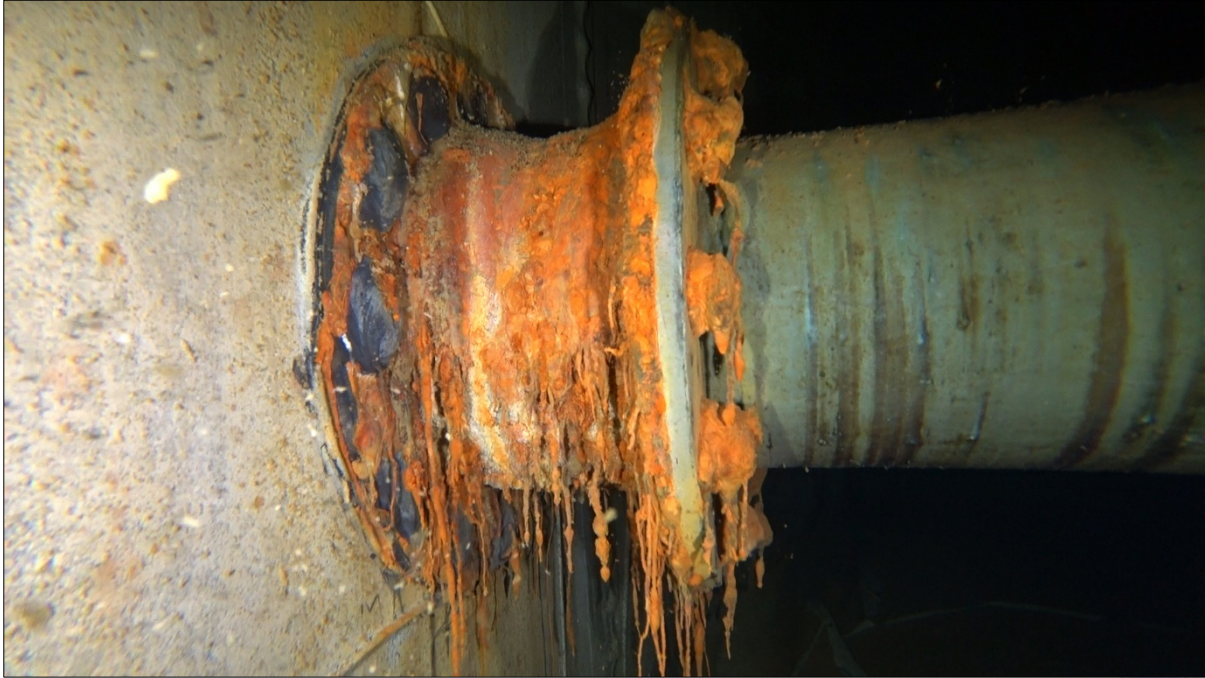
Internal Suction

Note: The spool piece and connection bolts are corroding.

- The liner should be replaced. We recommend a Butyl rubber liner.
 - Along with the above works, the following ancillaries should be replaced.
 - Drain valve c/w lagging box
 - Immersion heater
- The contents gauge should be replaced.
- The internal suction spool piece should be replaced.
- The overflow pipework should be cleaned and treated.
- Remove and blank off existing manway.
- Install a certified manway.
- The ball valve should be replaced.
- The suction lagging should be repaired/replaced as required.
- All submerged connection bolts and gaskets should be replaced.
- The missing bolt from the test return should be installed.

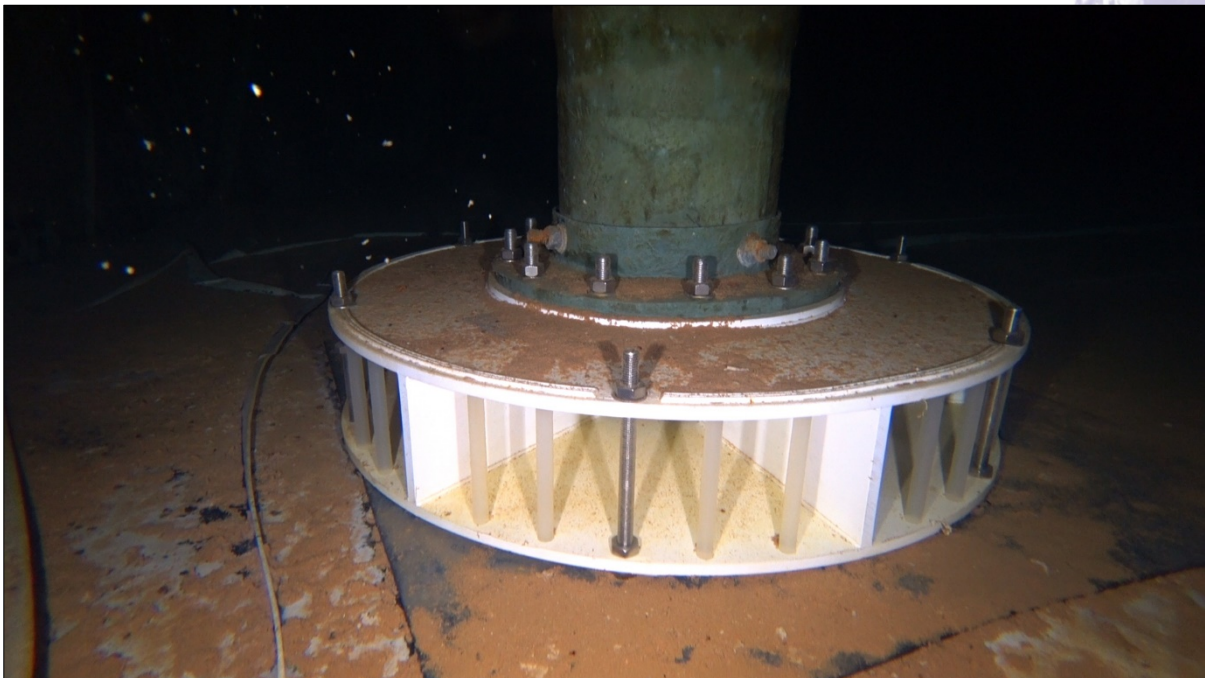
Internal Suction

Note: The pipework and vortex inhibitor are in a reasonable condition.

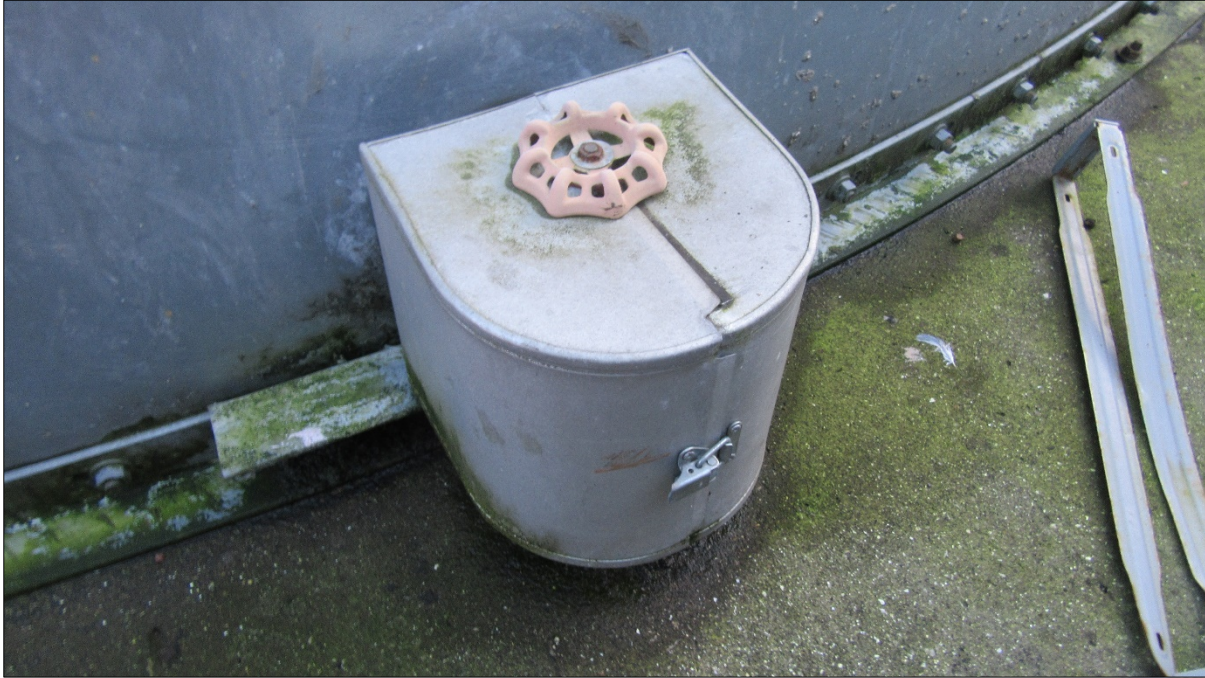
External Drain Valve

Note: The lagging is in a reasonable condition. The valve was not accessible to inspect.

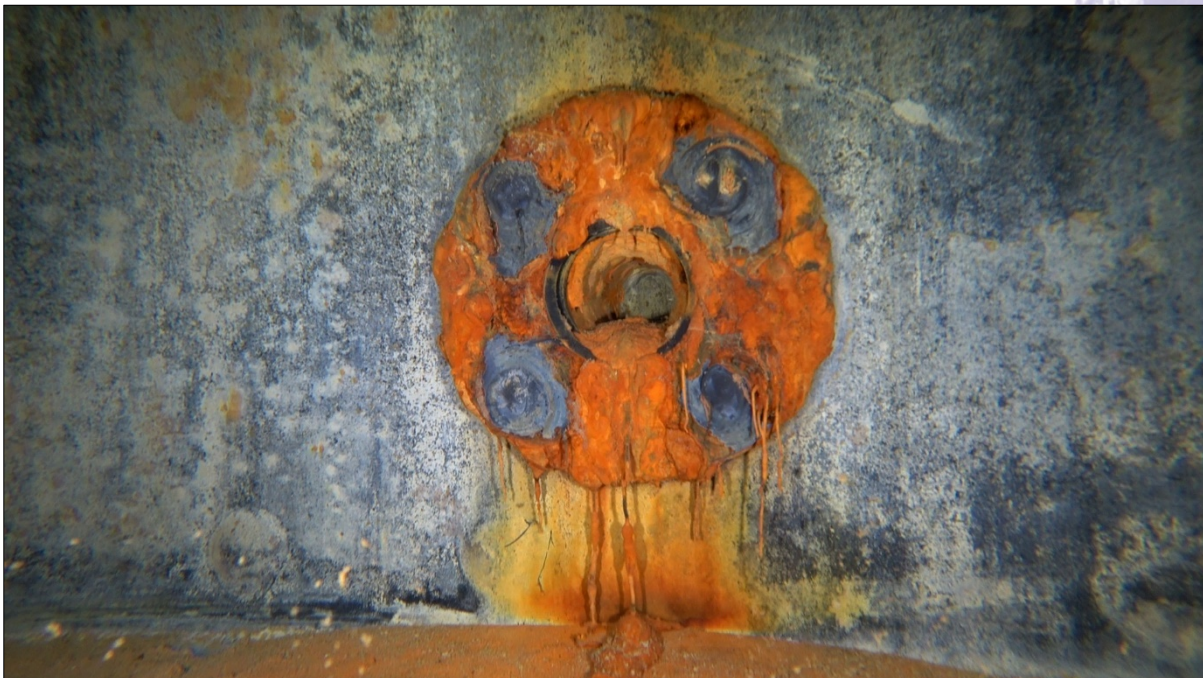
ROV Image of Drain Valve

Note: The connection bolts are sealed in mastic. The backing flange is corroding.

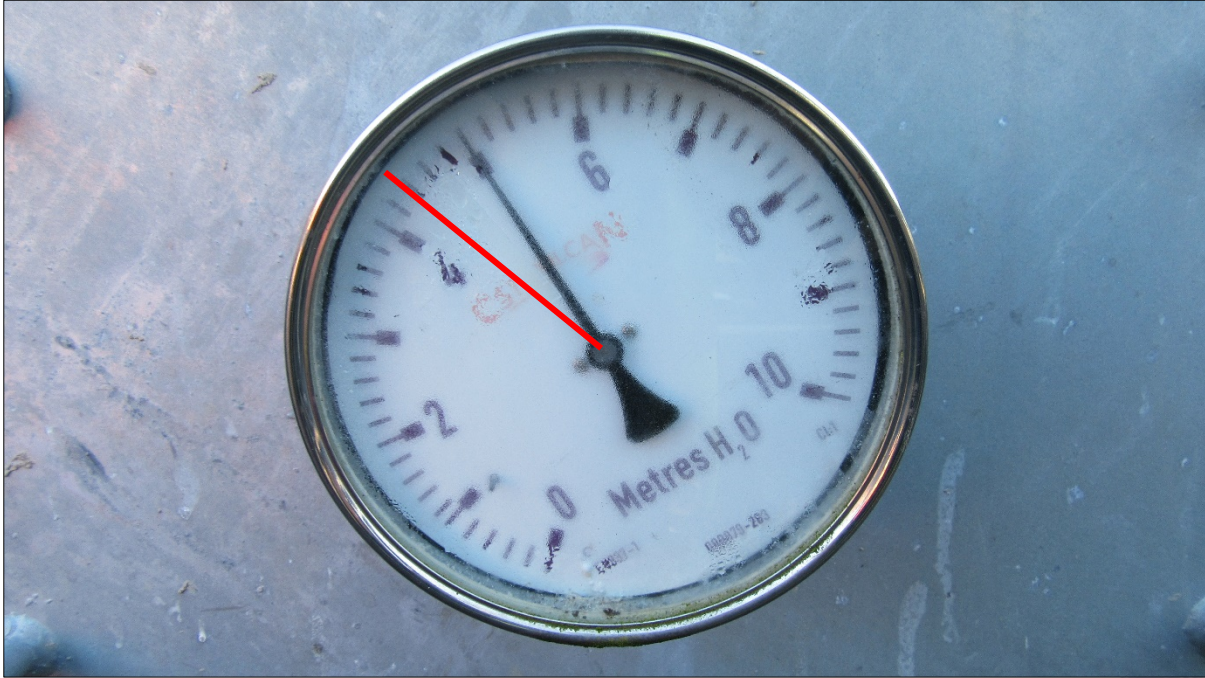
External Gauge

Note: The gauge is not reading correctly. Condensation is present behind the glass.

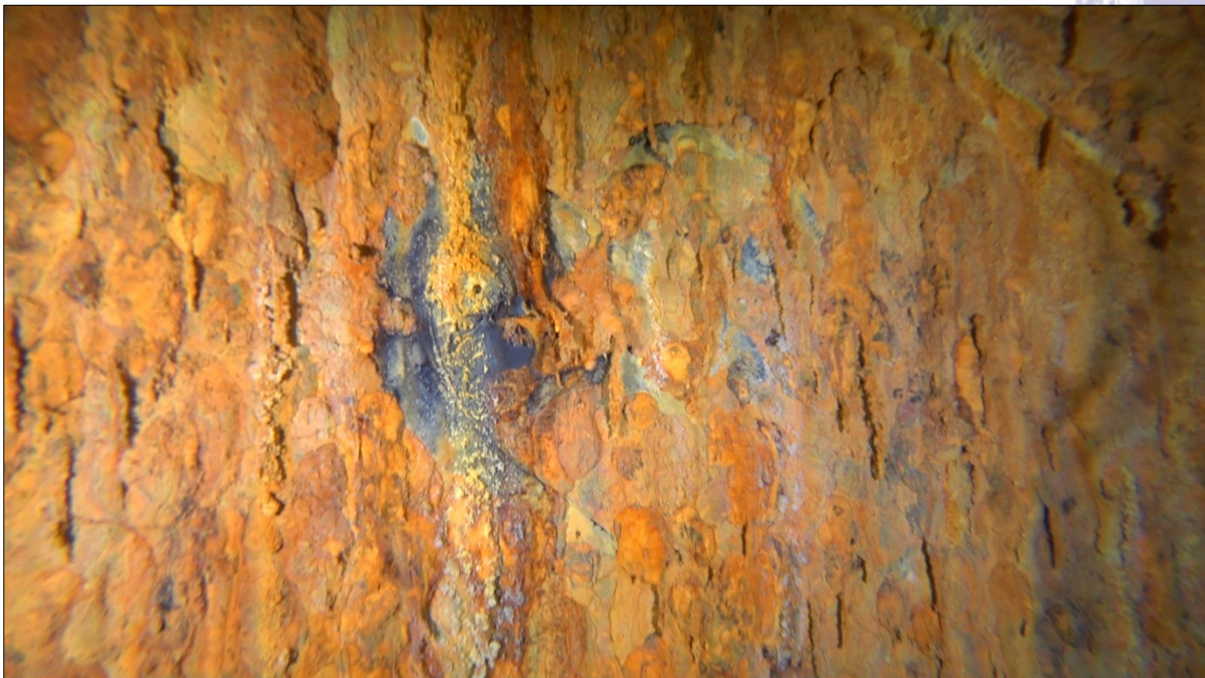
ROV Image of Gauge

Note: The no loss connection is sealed in mastic.

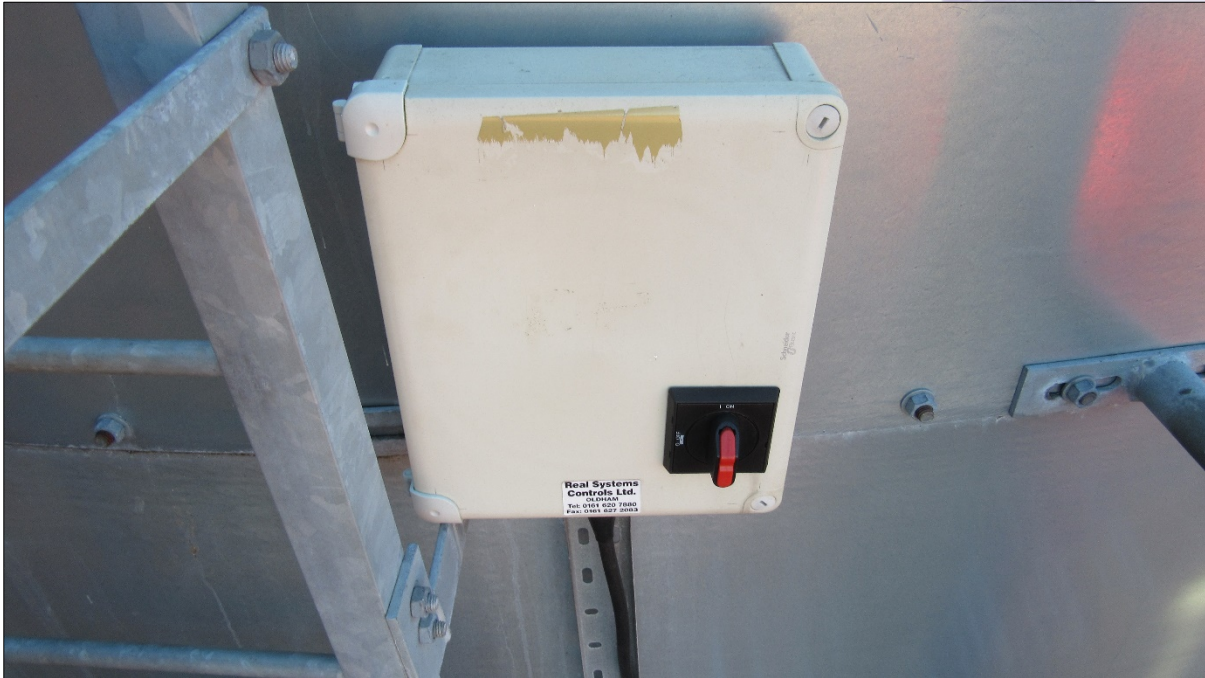
External Immersion Heater

Note: The control box is in a reasonable condition.

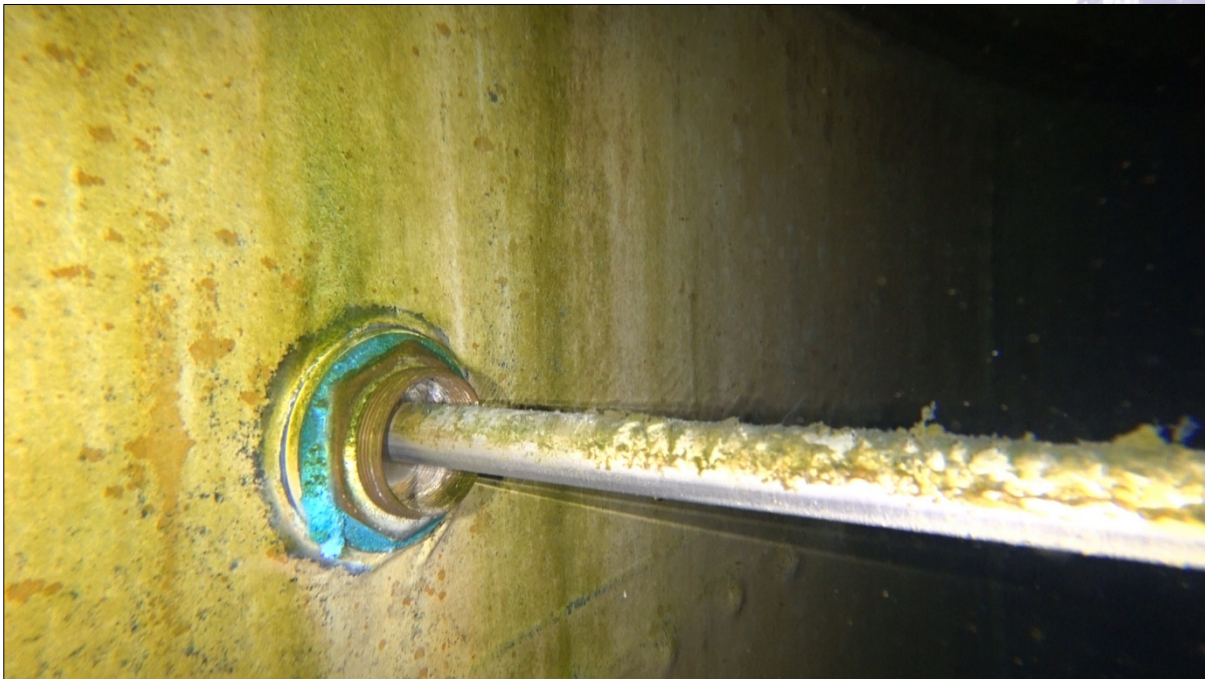
ROV Image of Immersion Heater

Note: Corrosion is visible on the connection flange. Algae growth is present on the sheath.

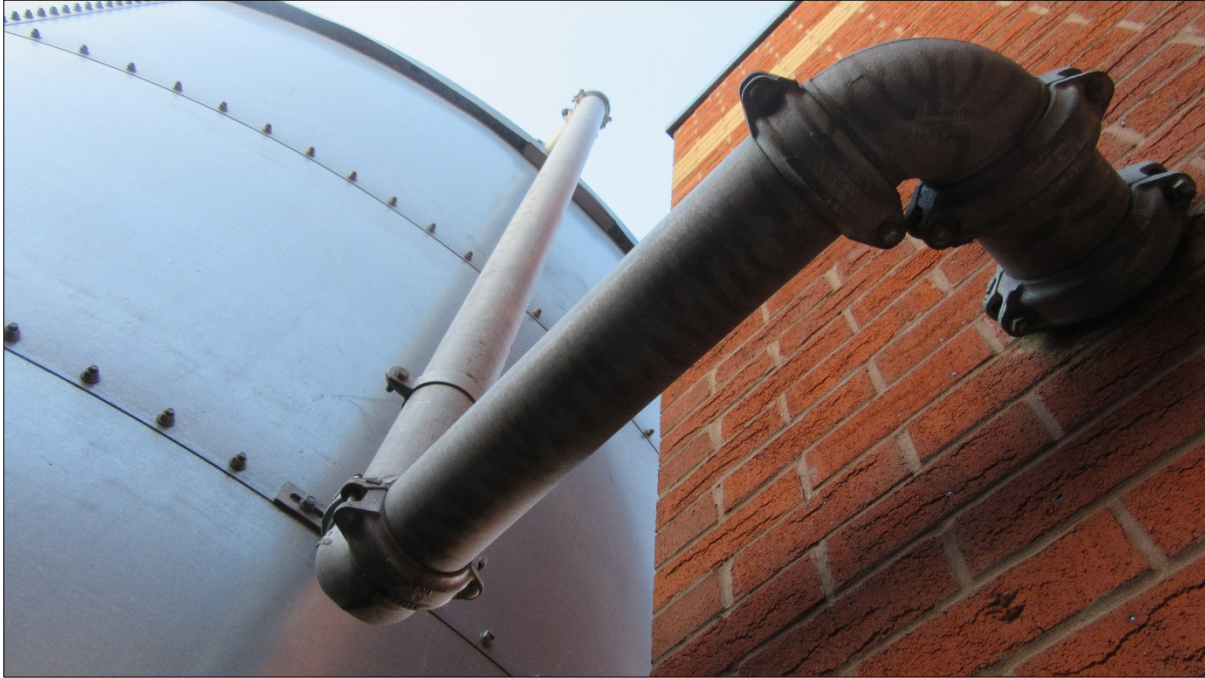
External Test Return

Note: The pipework is in a good condition.

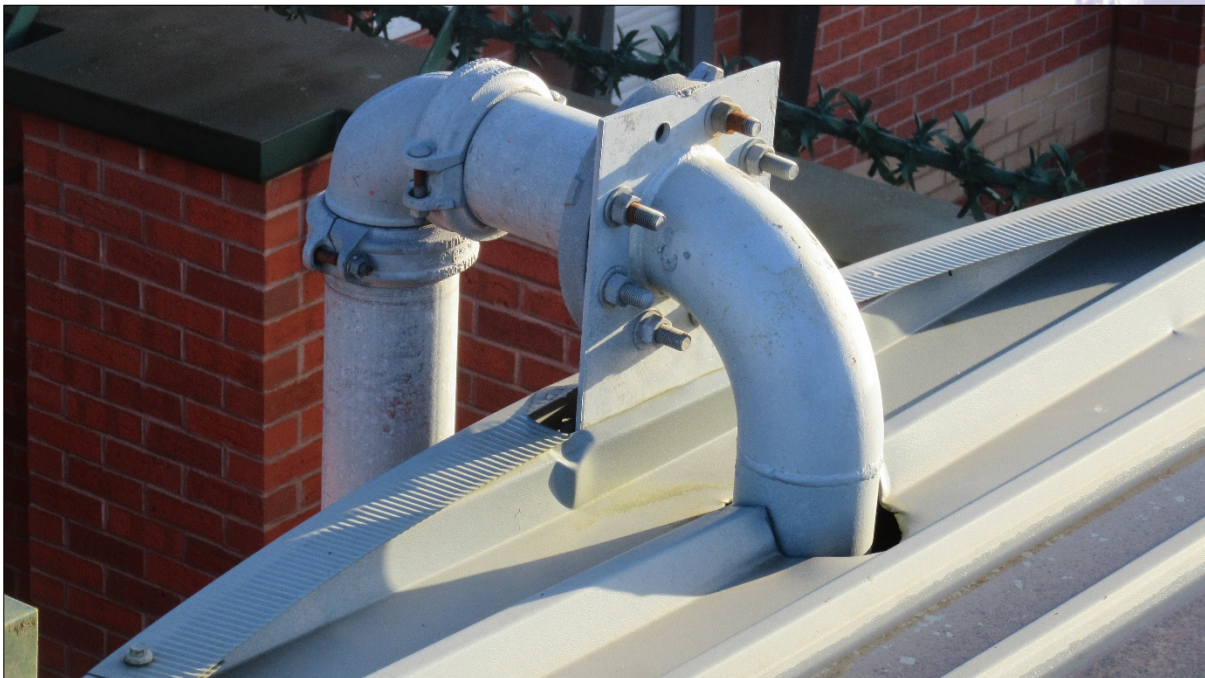
Note: A connection bolt is missing off the pipework.

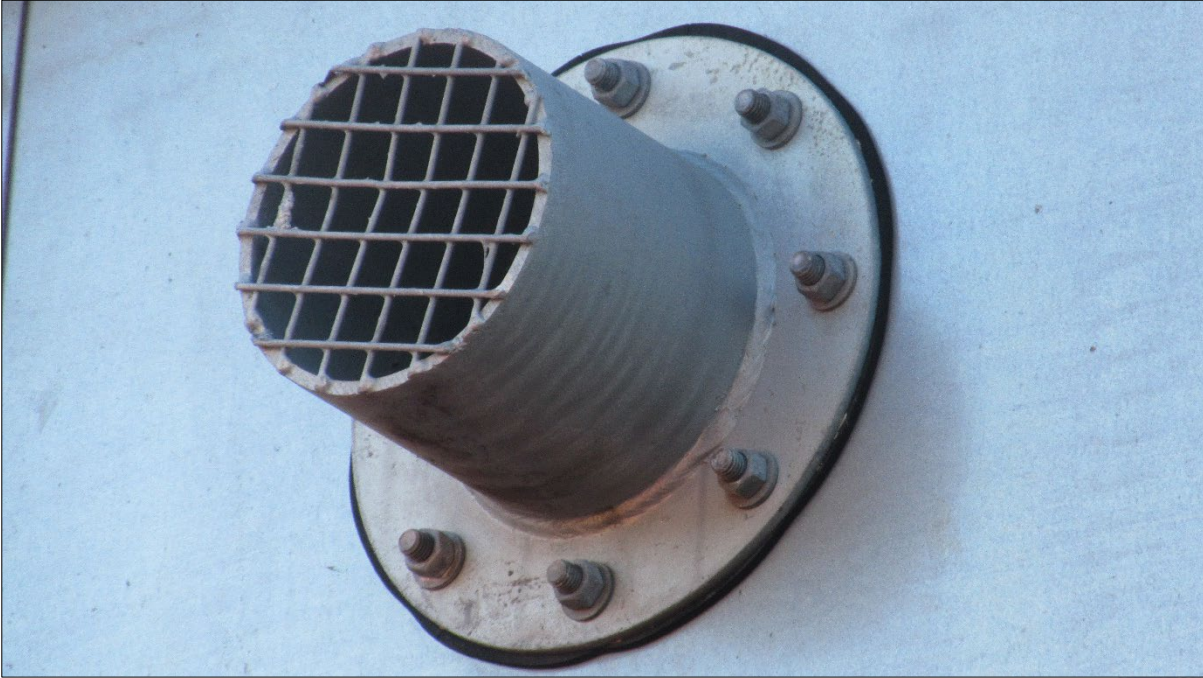
External Overflow

Note: In a good condition.

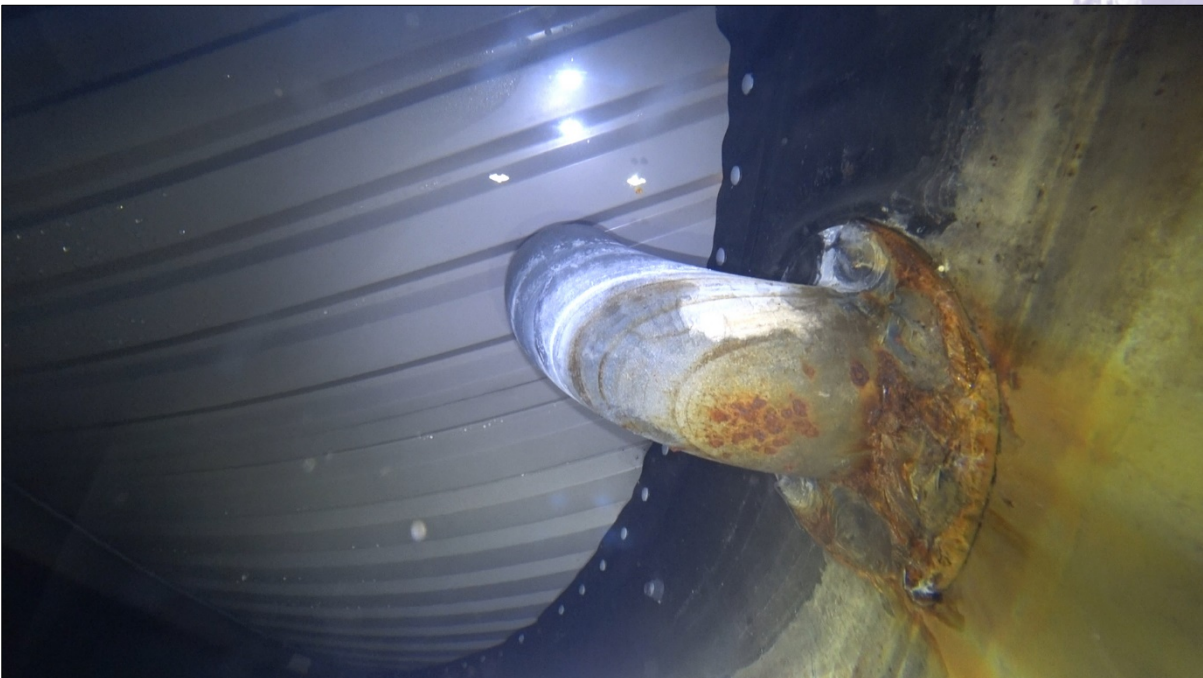
ROV Image of Overflow

Note: Corrosion is present.

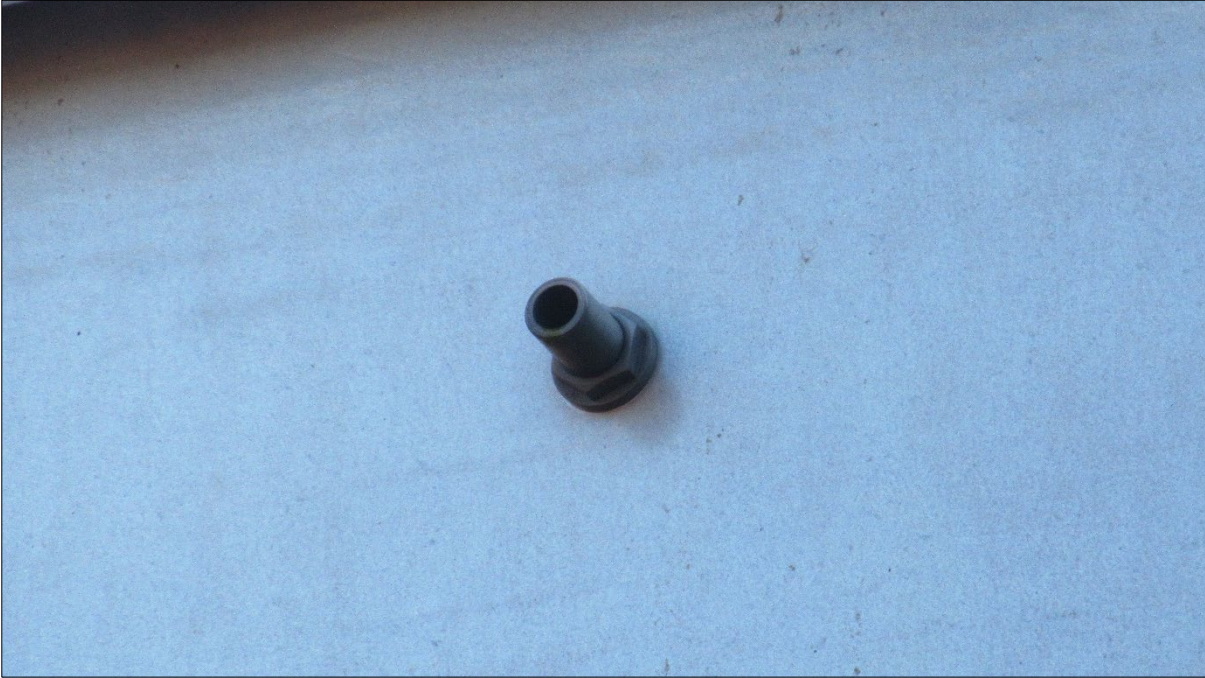
Note: In a good condition.

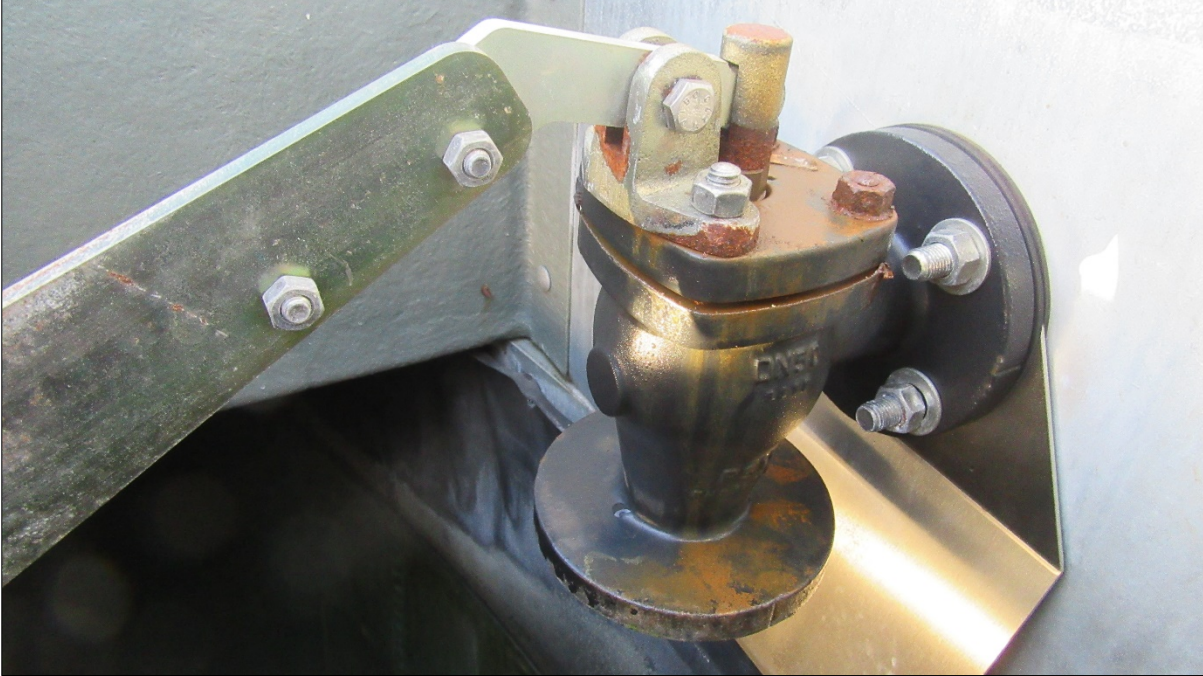
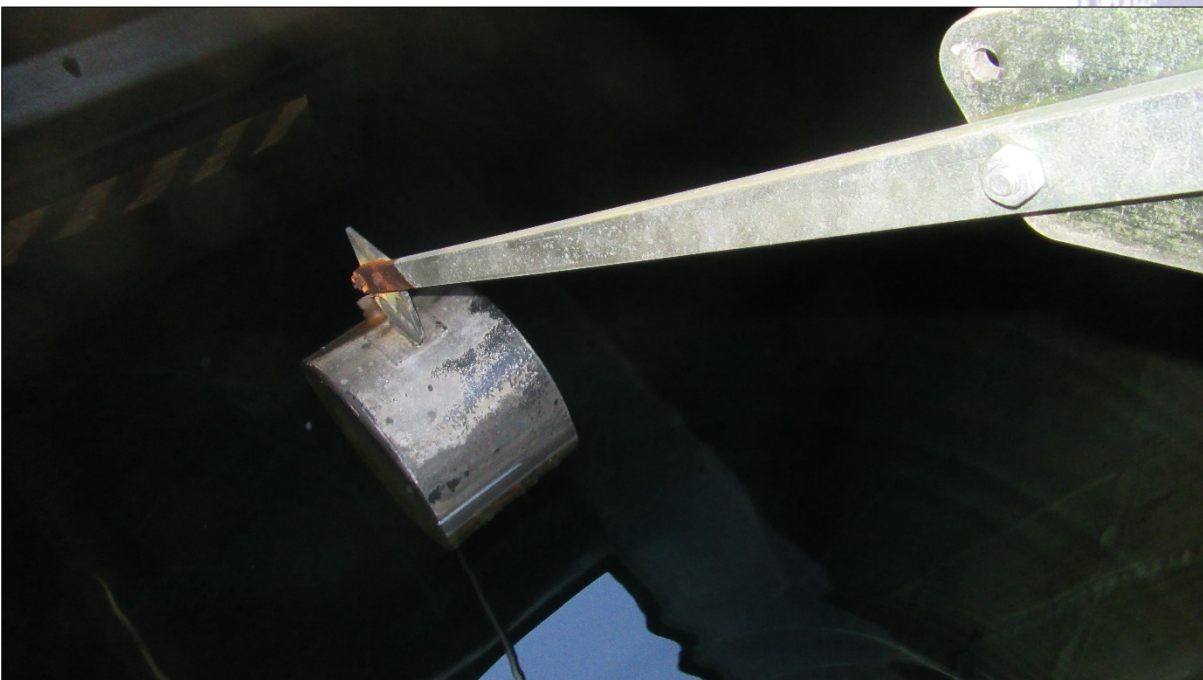
Note: Corrosion is present.

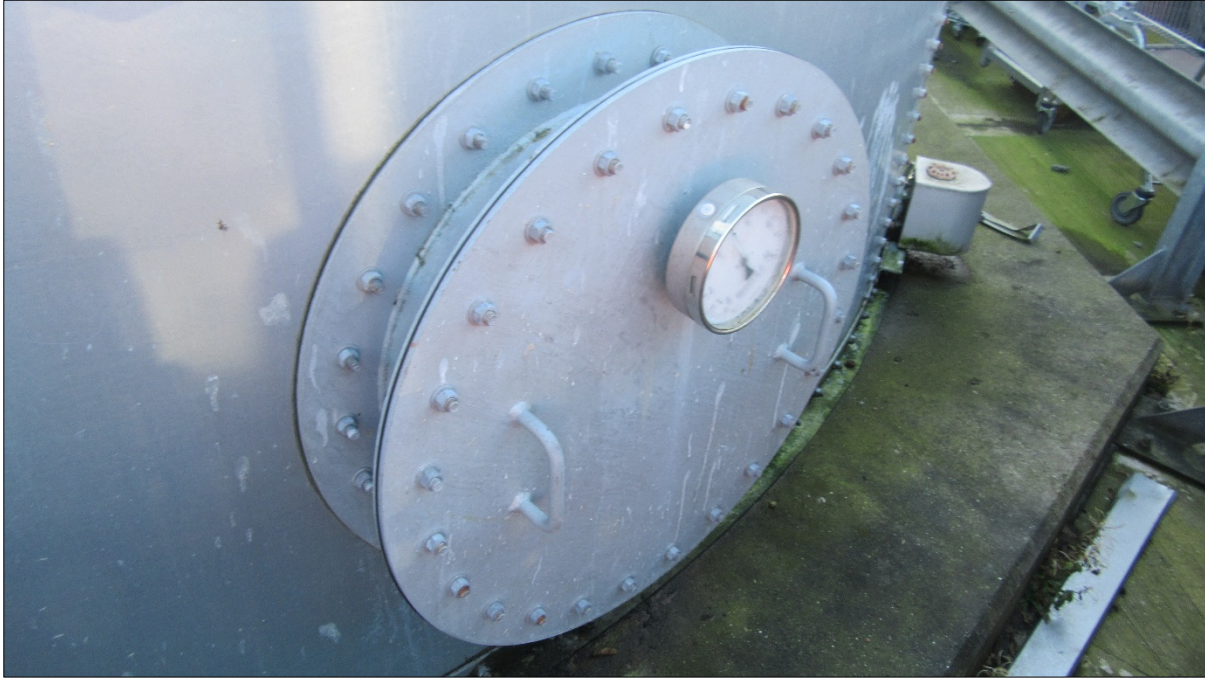
External Manway

Note: In a good condition.

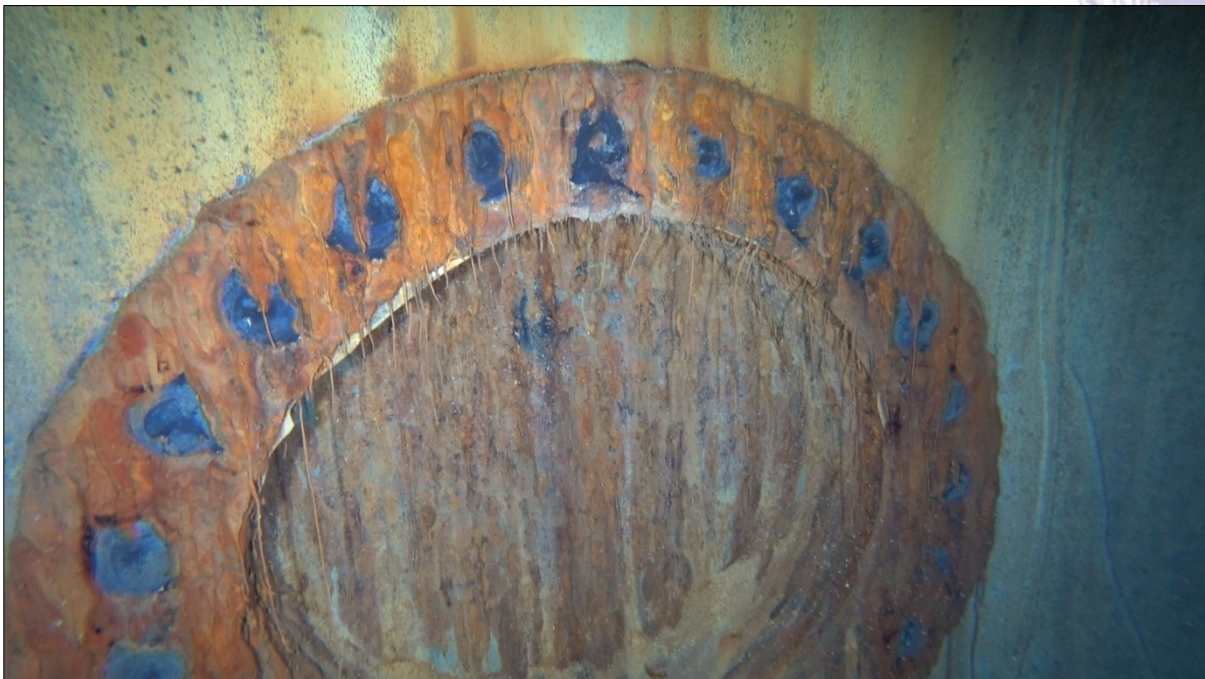
ROV Image of Manway

Note: Corrosion is present on the flange and internal lid surface.

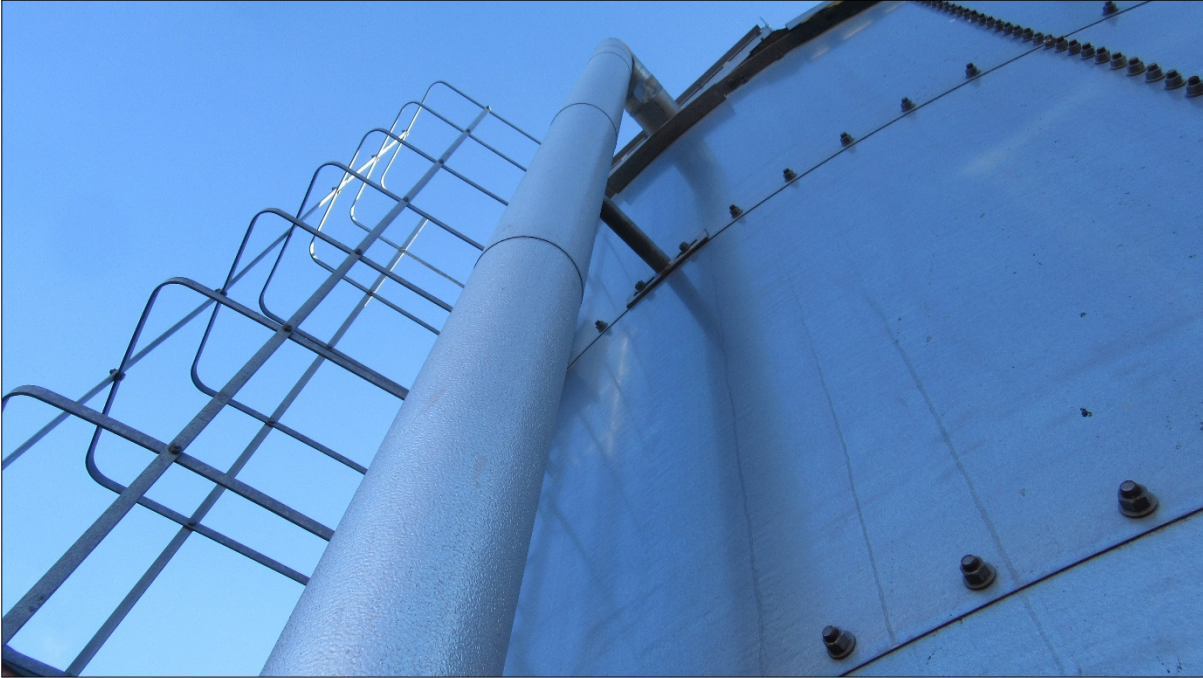
Note: The pipework bracket is in a good condition.

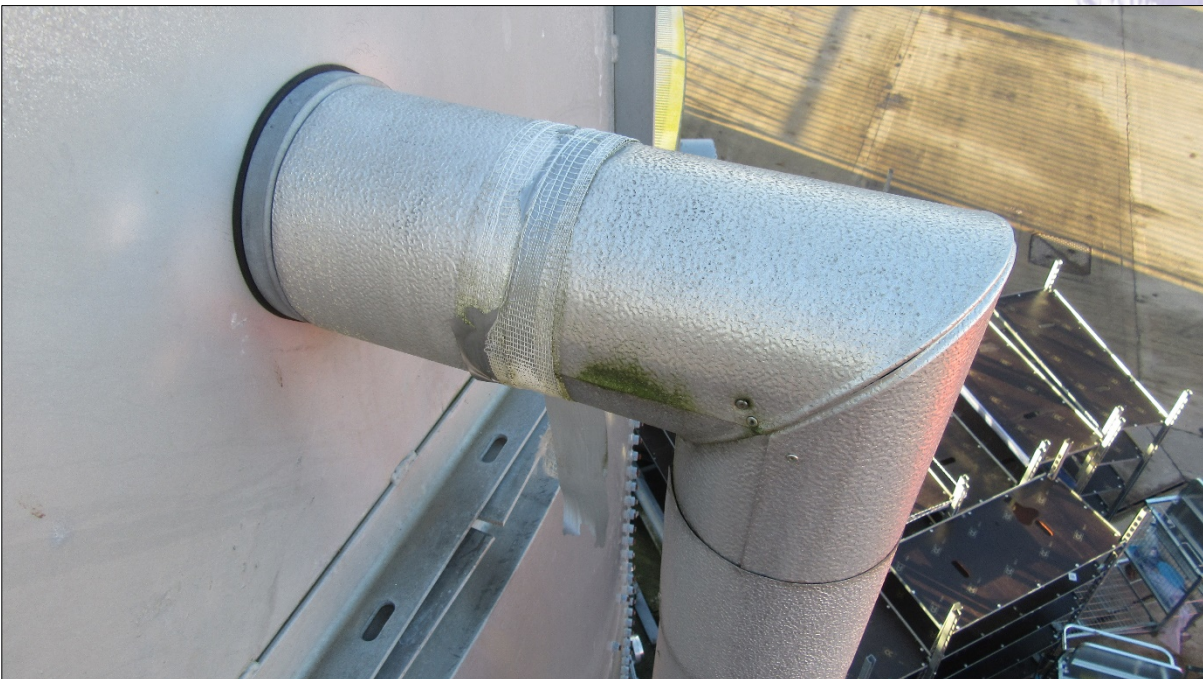
Note: The lagging is in a reasonable condition.

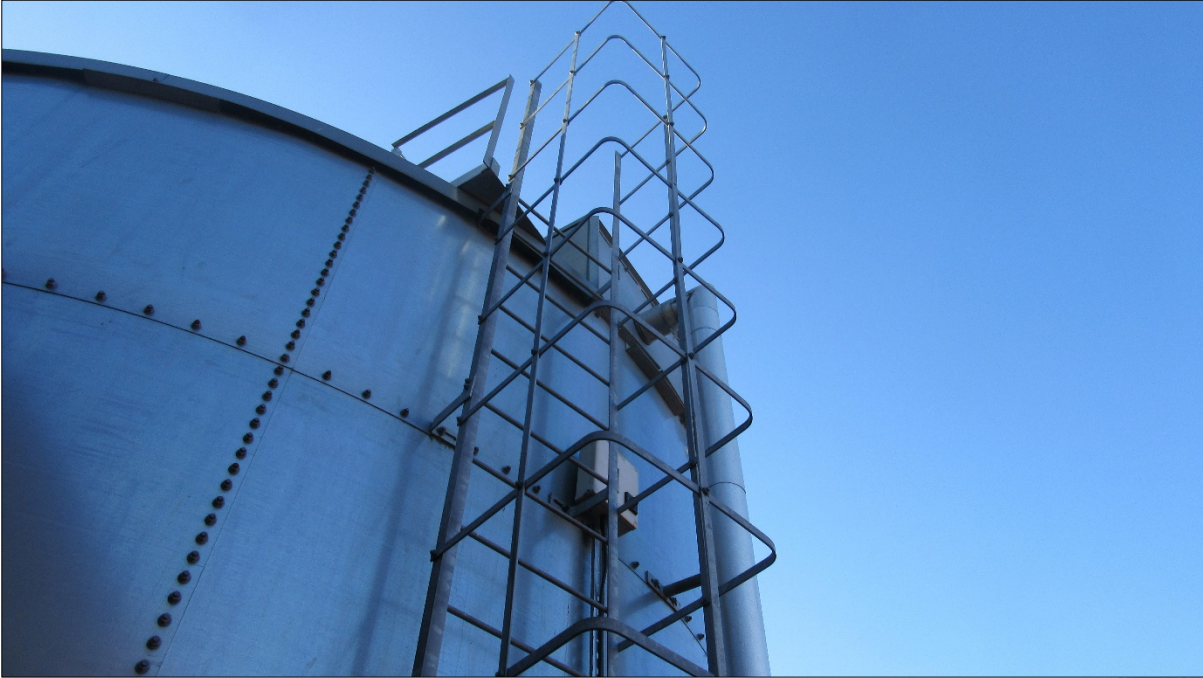
Note: The ladder is in a good condition.

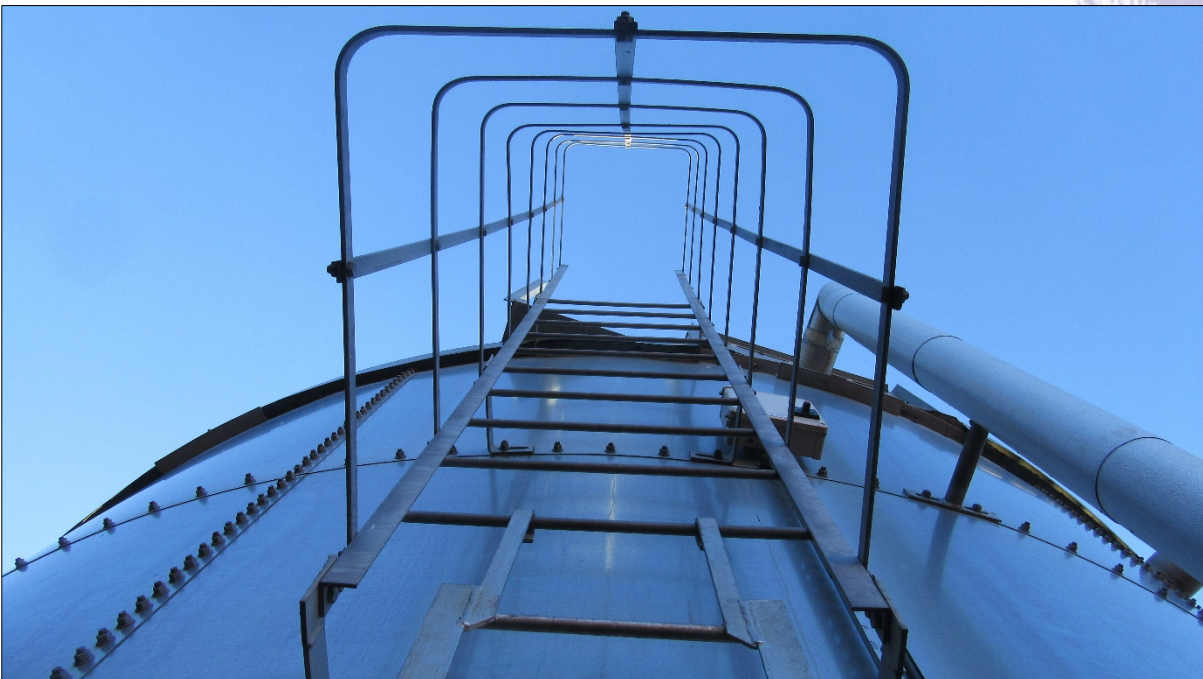
Note: The safety hoops are in a good condition.

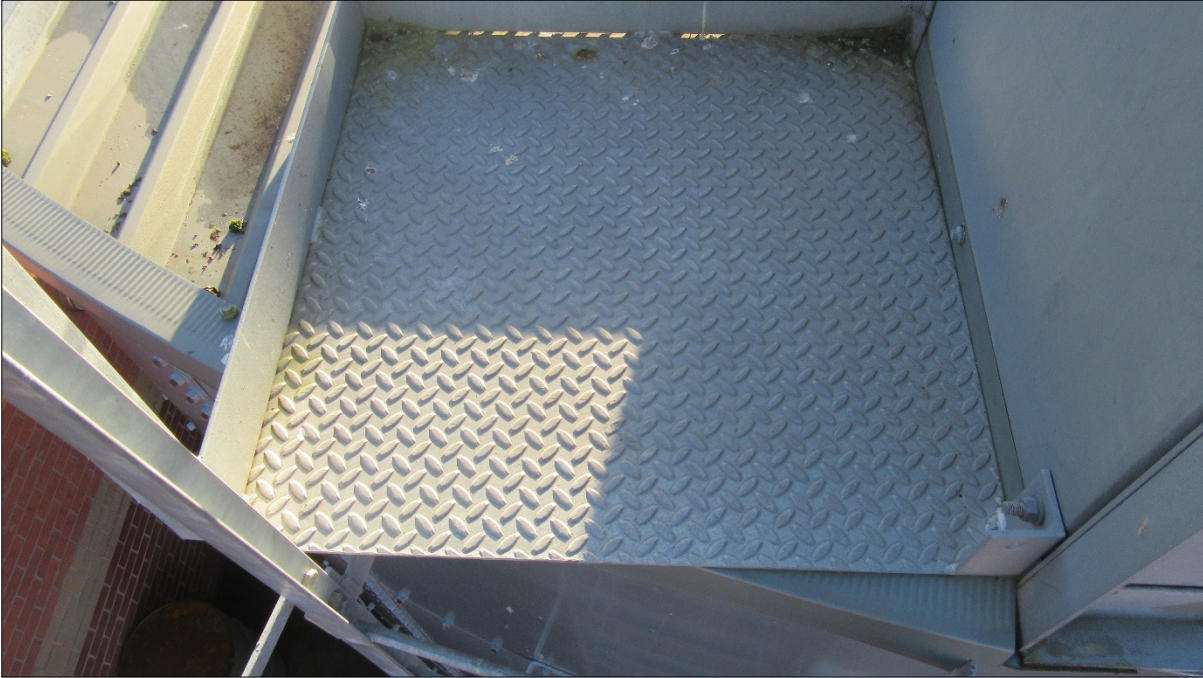
Note: The platform is in a good condition.

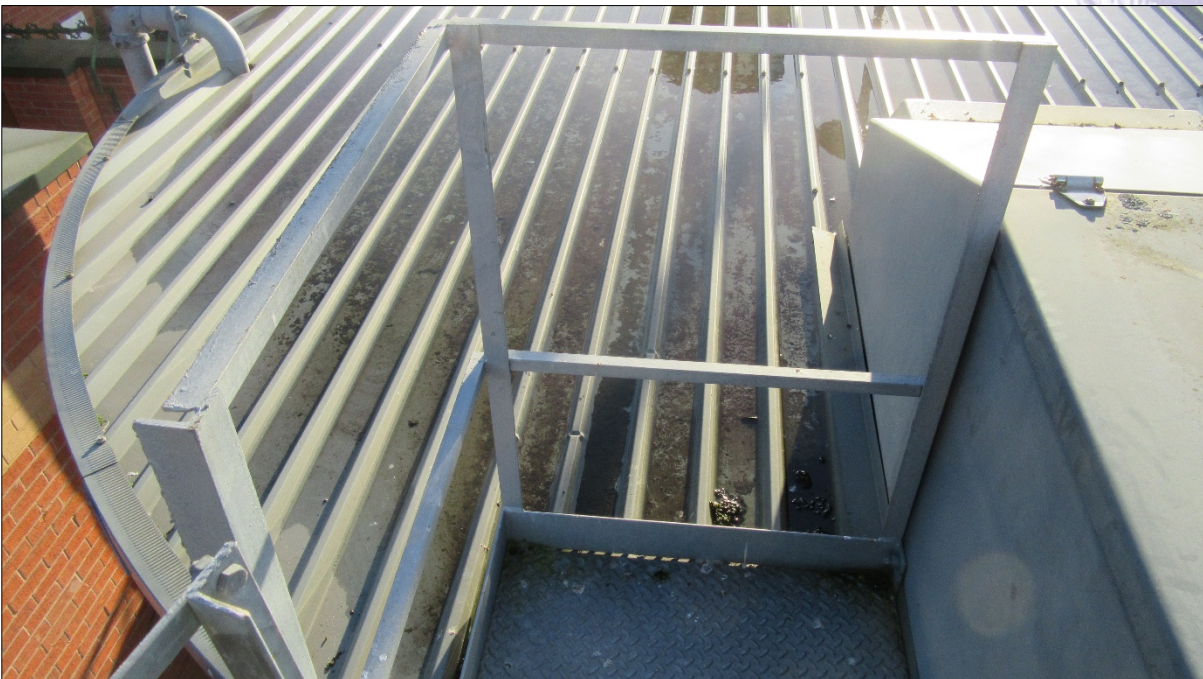
Note: The handrails are also in a good condition.
