ROV Sprinkler Tank Inspection Sample Report

Reference: 123456789

Date of Inspection: 00/00/0000

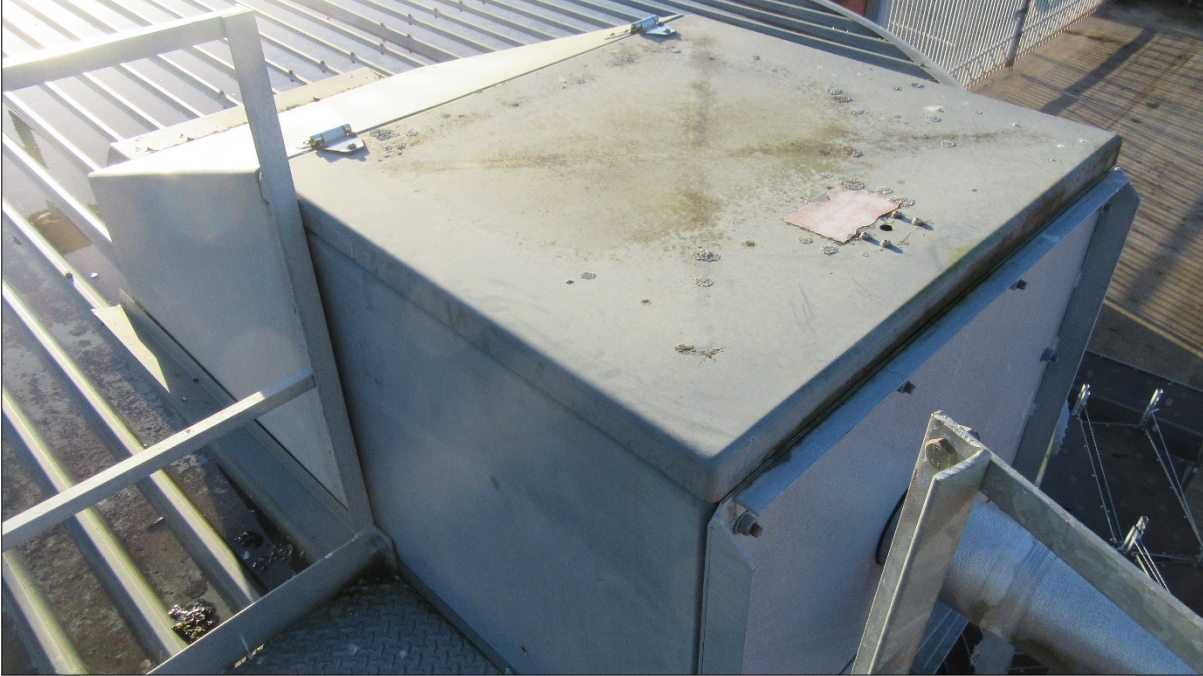
Note: The housing is in a good condition.

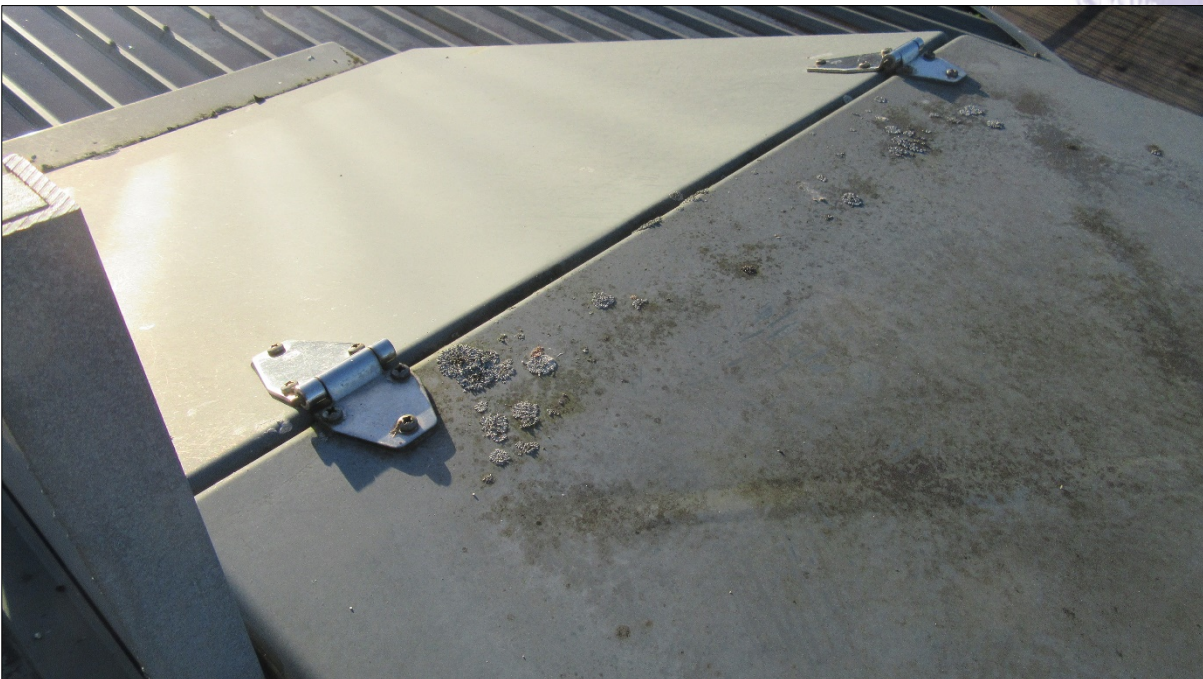
Note: The lid is present and secure.

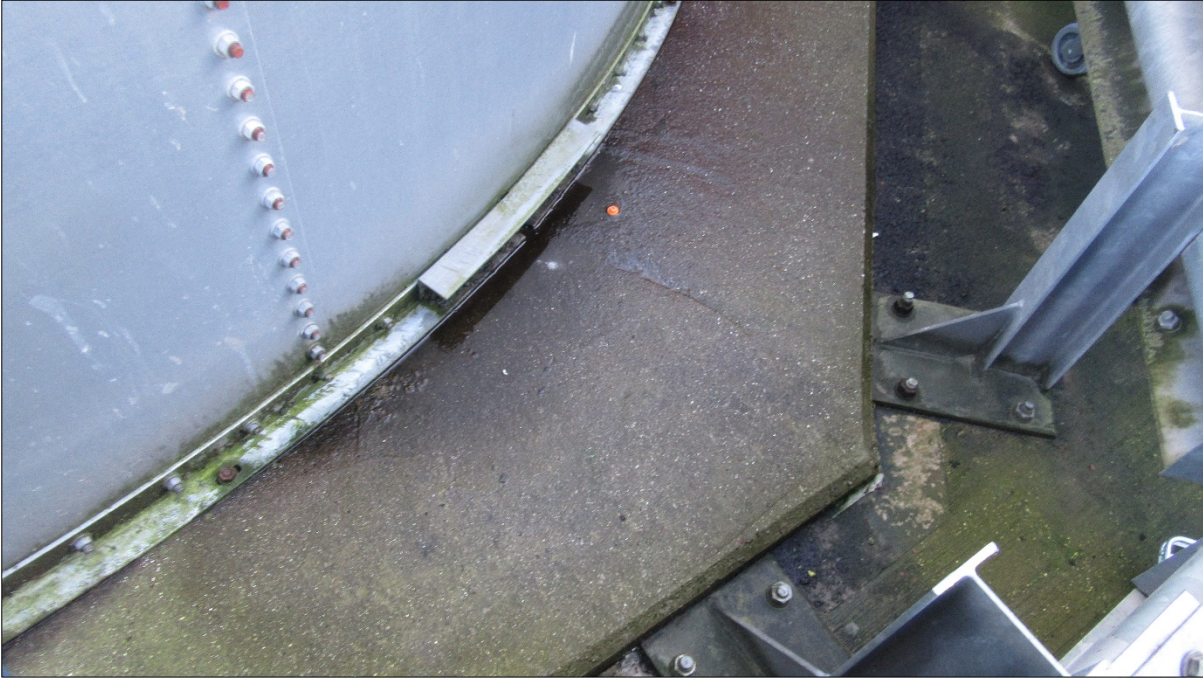
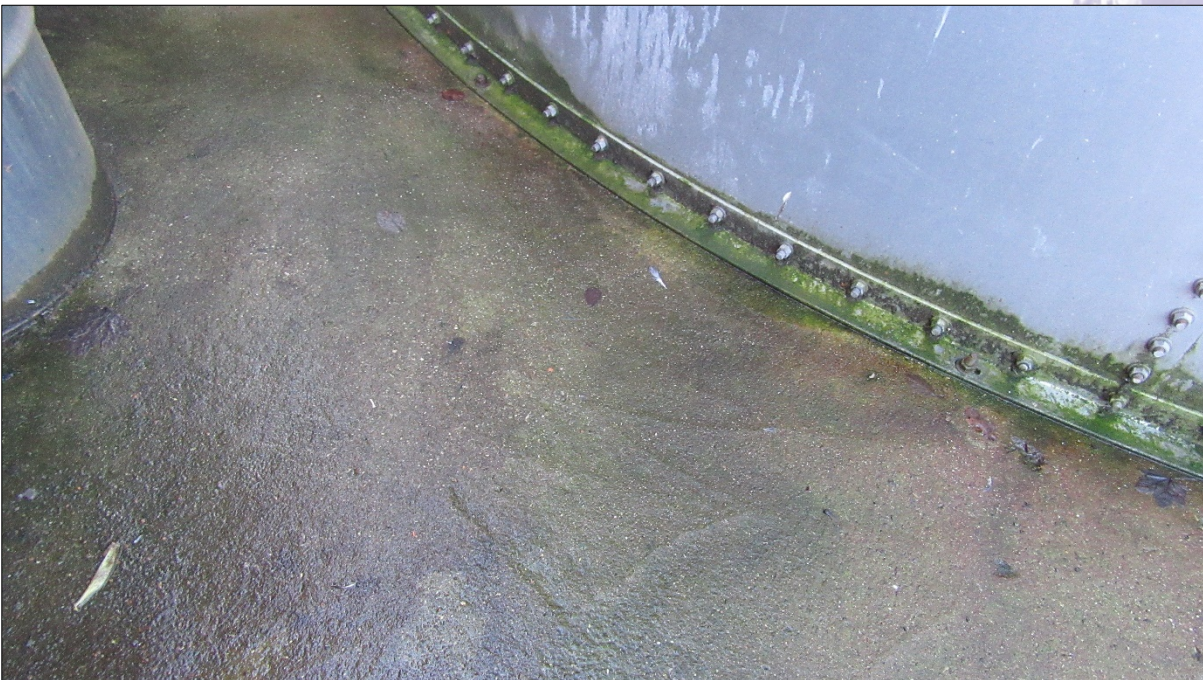
Note: Where visible, the foundation is in a good condition.

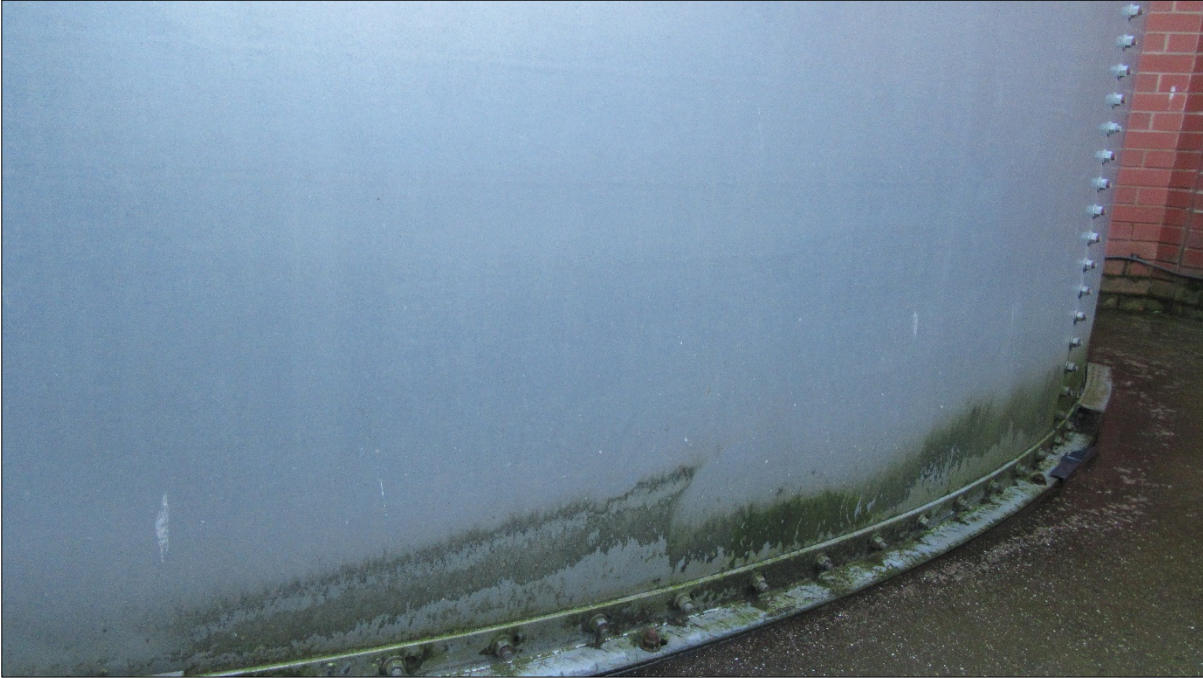
Note: Some light moss staining is present on the shell.

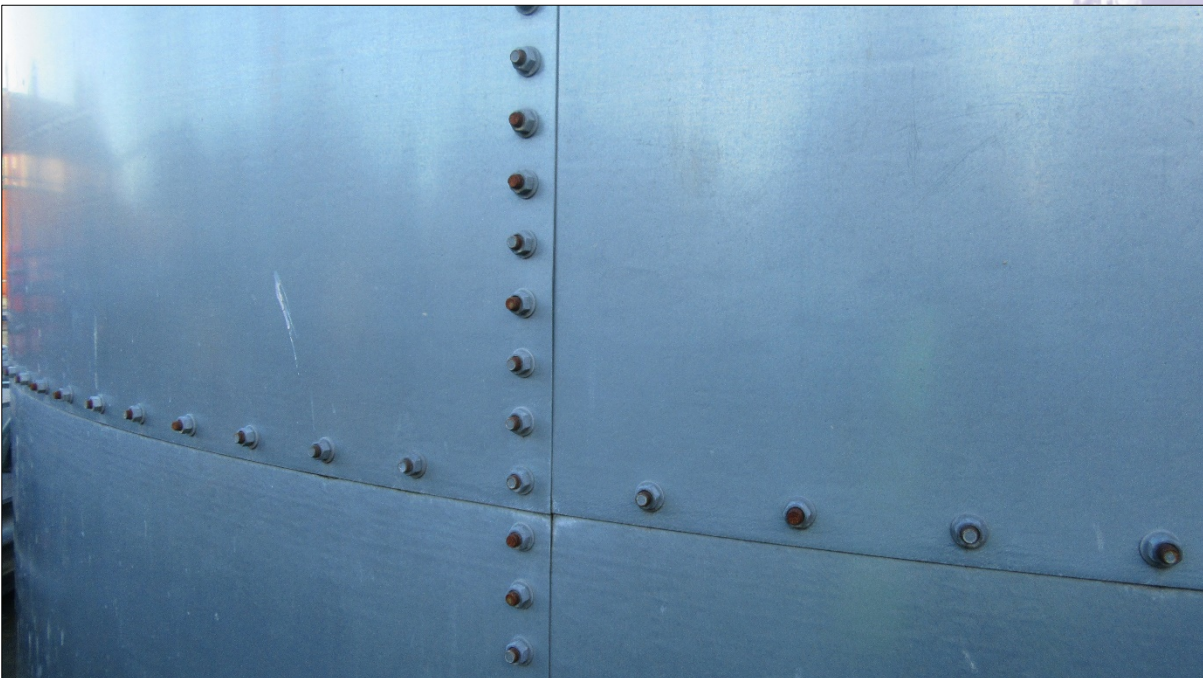
Note: The shell is in a good condition.

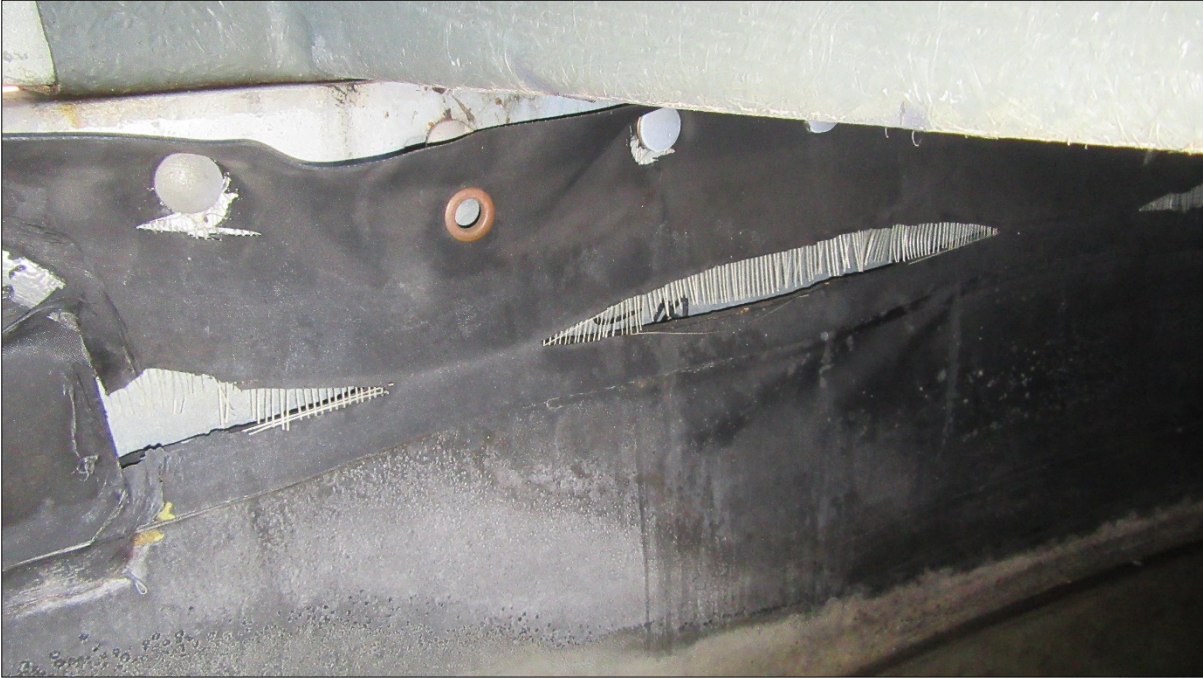
Note: The liner is shrinking and tearing.

- The liner should be replaced. We recommend a Butyl rubber liner.
 - Along with the above works, the following ancillaries should be replaced.
 - Drain valve c/w lagging box
 - Immersion heater
- The contents gauge should be replaced.
- The internal suction spool piece should be replaced.
- The overflow pipework should be cleaned and treated.
- Remove and blank off existing manway.
- Install a certified manway.
- The ball valve should be replaced.
- The suction lagging should be repaired/replaced as required.
- All submerged connection bolts and gaskets should be replaced.
- The missing bolt from the test return should be installed.

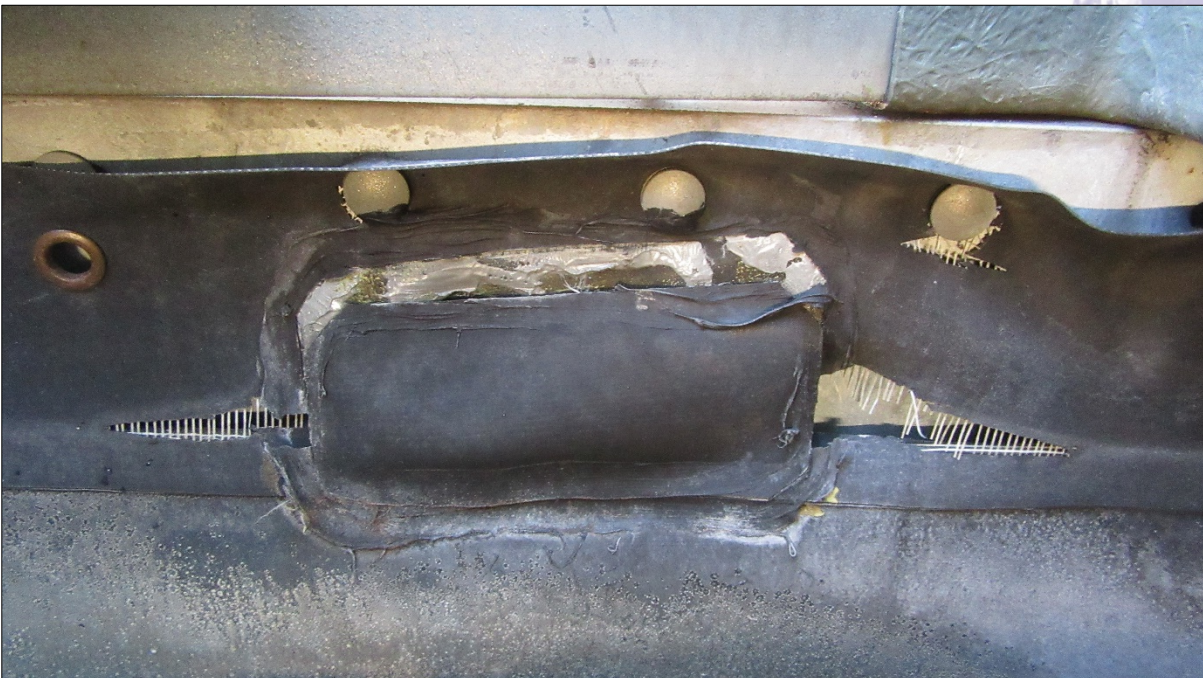
Note: A repair has been made to the liner.

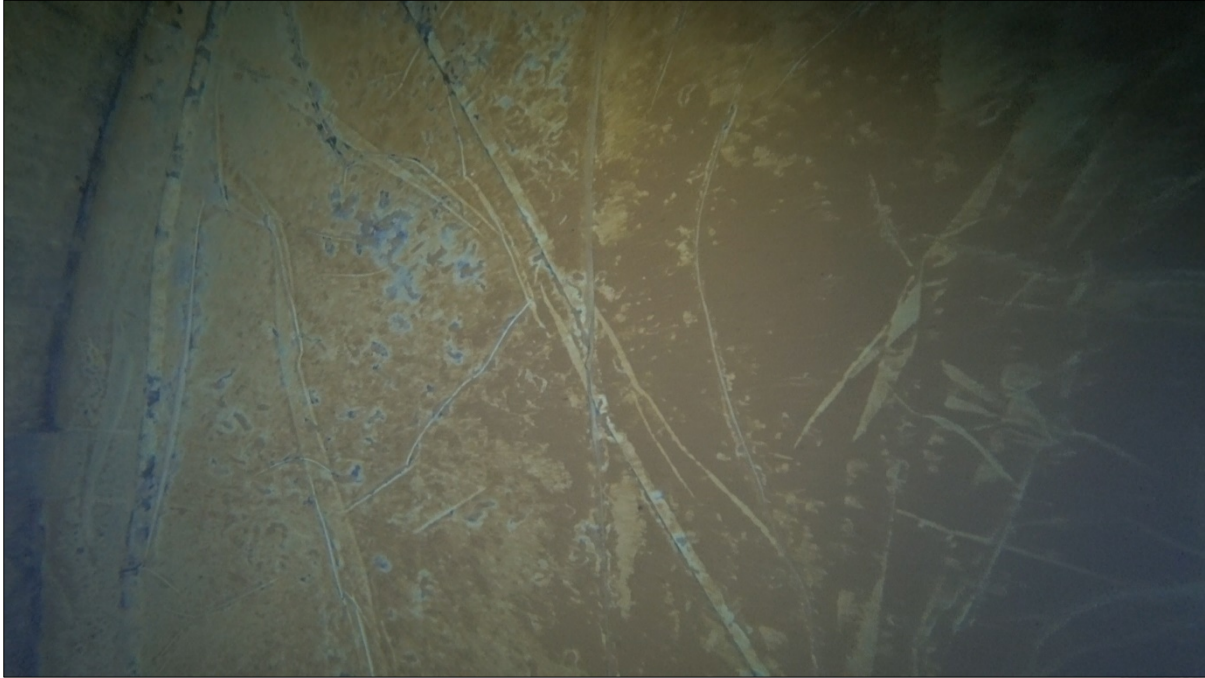
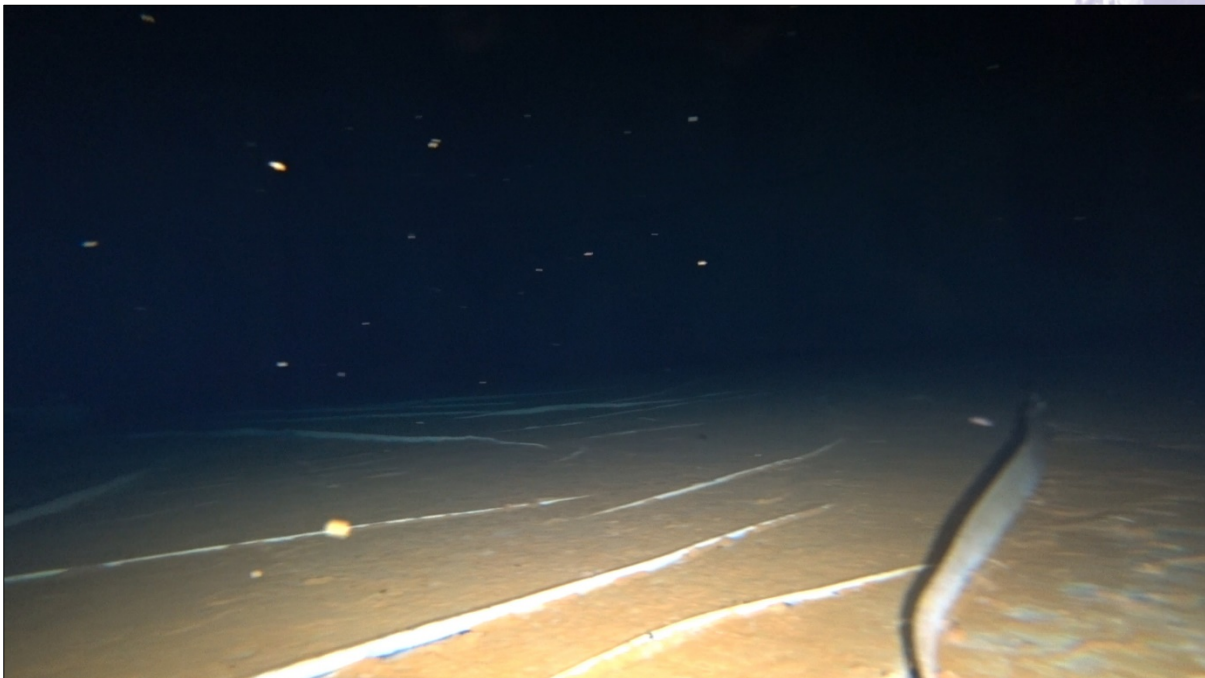
Note: Silt is present on the liner floor.

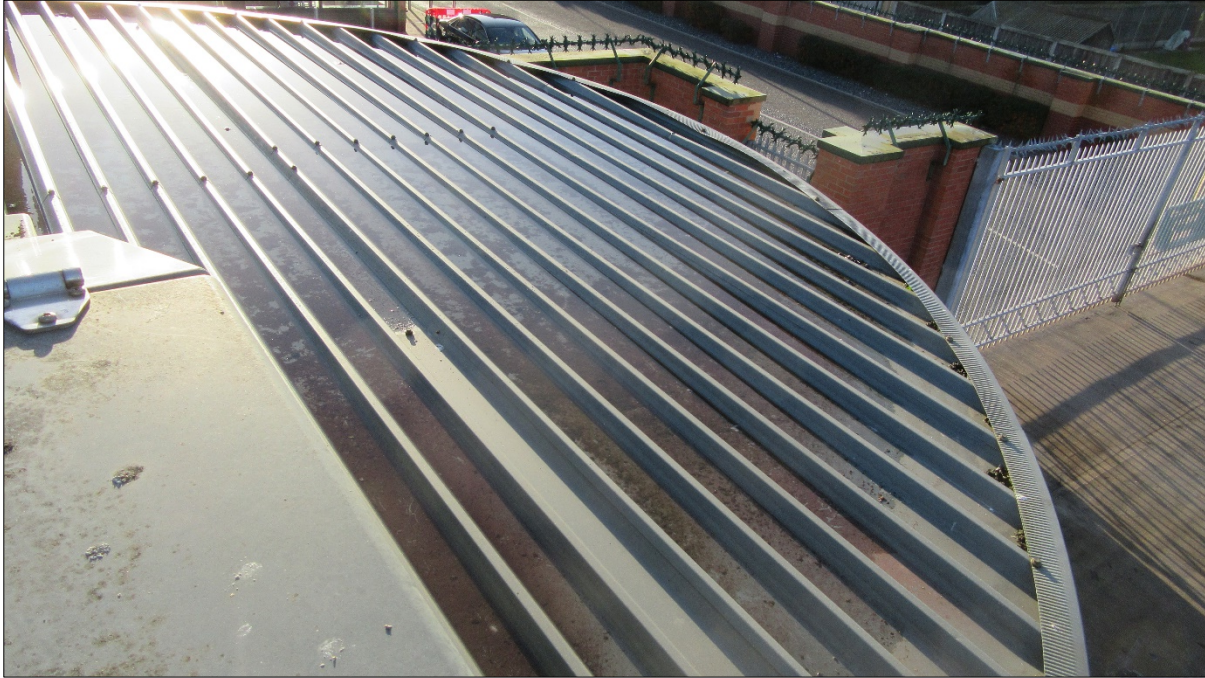
Note: The roof sheets are in a good condition.

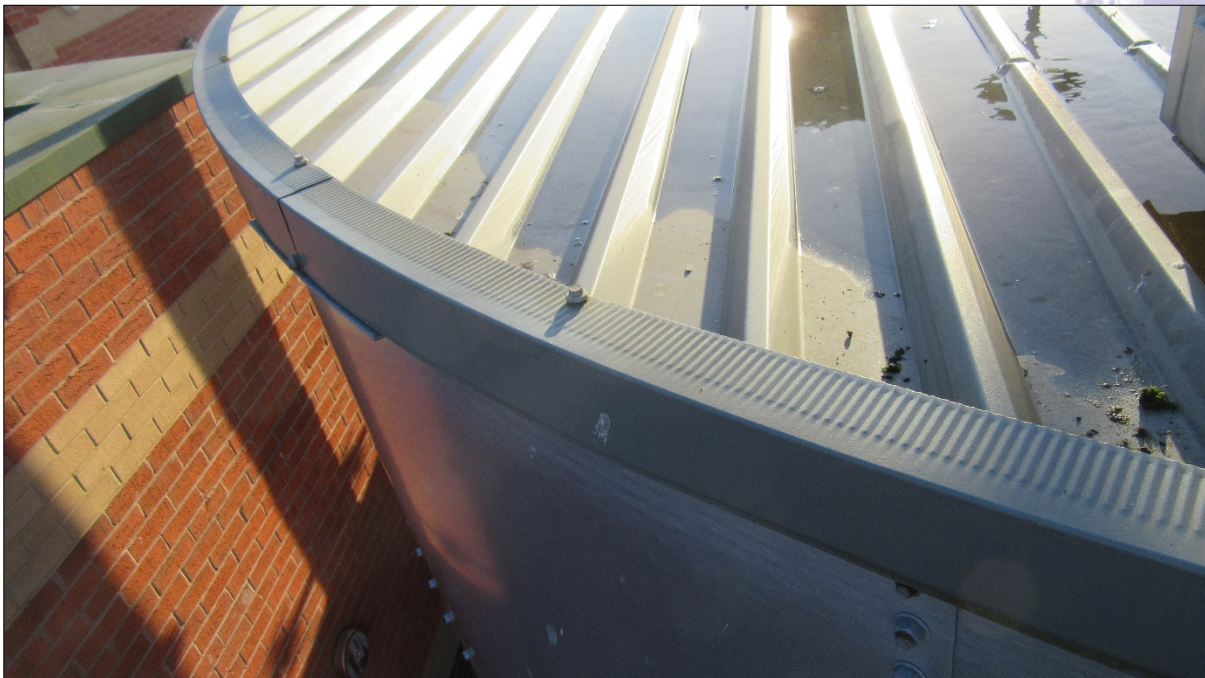
Note: The flashing is also in a good condition.

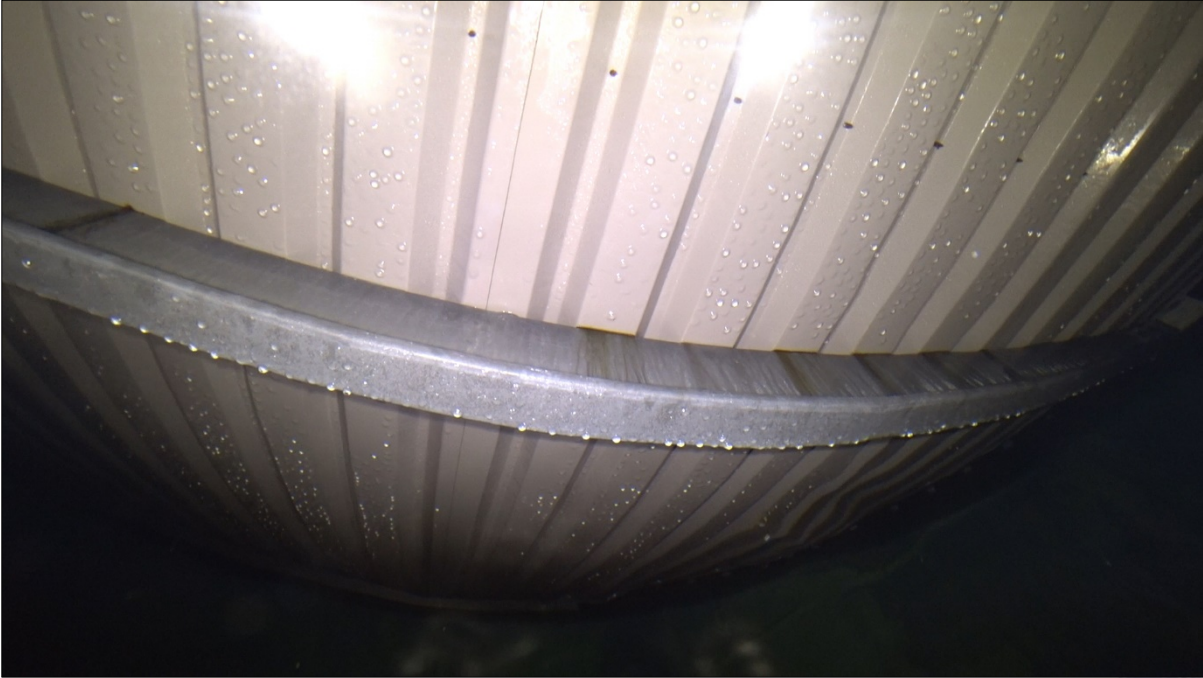
Note: The roof purlins are in a good condition.

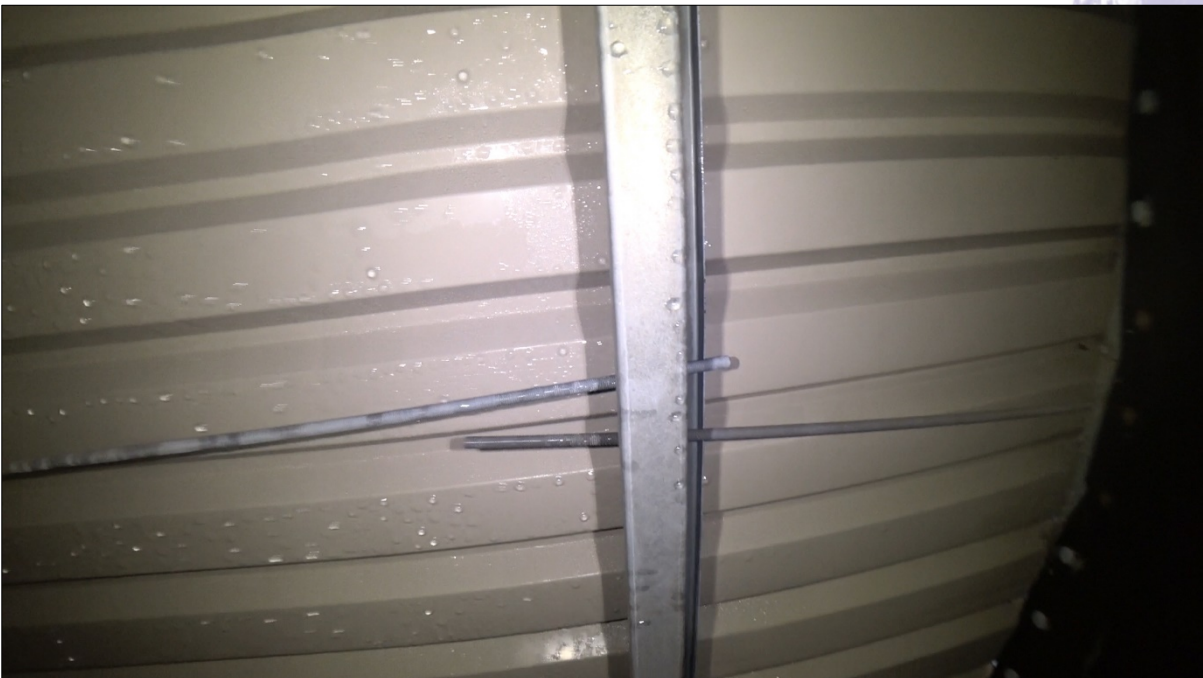
Note: No corrosion is visible.
